QUINNIPIAC RIVER BASIN  
WALLINGFORD, CONNECTICUT

# SIMPSON POND DAM CT 00630

## PHASE I INSPECTION REPORT NATIONAL DAM INSPECTION PROGRAM

Identification Number:	CT 00630
Name:	Simpson Pond Dam
Town:	Wallingford
County and State:	New Haven County, Connecticut
Stream:	Wharton Brook
Date of Inspection:	October 23, 1980

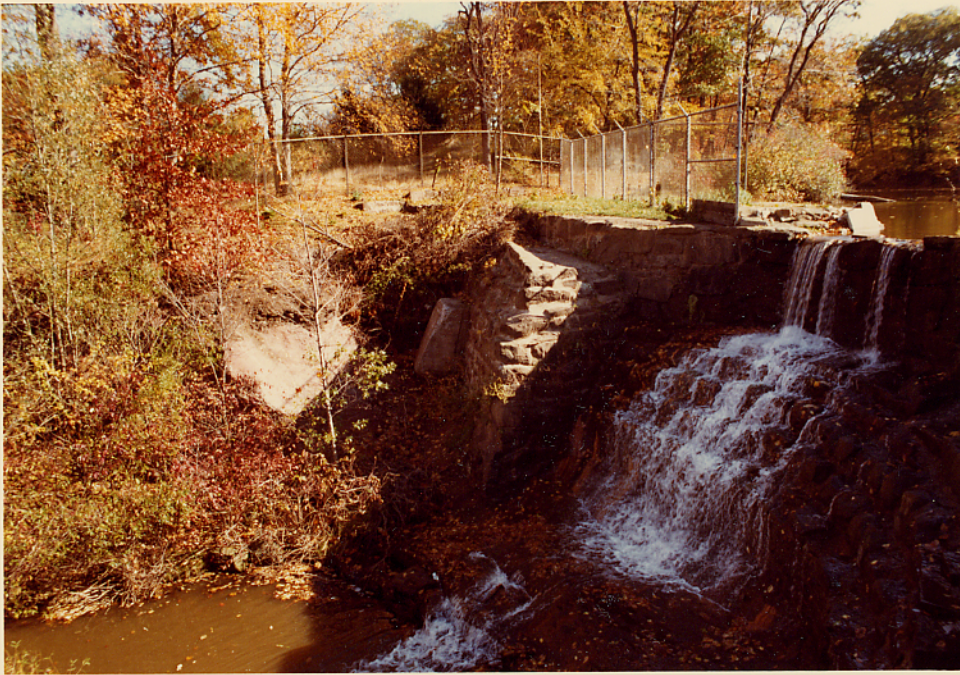
c. Appurtenant Structures - The main spillway is 42 feet long and the auxiliary spillway is 55 feet long (Photo 1). At the base of the main spillway is a solid stone apron. Several capstones are missing from the top of the main spillway and near the south abutment water is flowing under the capstones. The north abutment

is 1 foot above the main spillway. There is a 55-foot auxiliary spillway north of the main spillway, (Photo 1) with a chain link fence along the crest. This fence has debris collecting on the upstream side and does inhibit flow when the auxiliary spillway is in use. The downstream face is mortared stone masonry. There is a large scour hole in the downstream channel bank below the auxiliary spillway caused by water flowing over the auxiliary spillway (Photos 1 and 4).

PHOTO 1  
TOP OF DAM - SPILLWAY - NORTH ABUTMENT

(2) Repair and replace capstones on the main spillway weir.

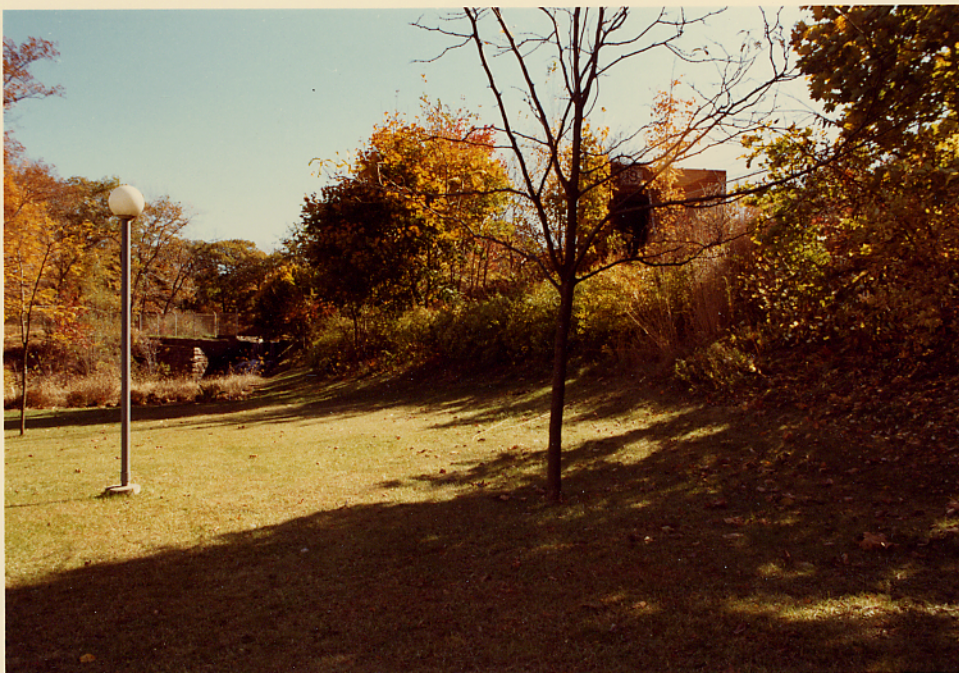
PHOTO 2  
DOWNSTREAM FACE LOOKING NORTH

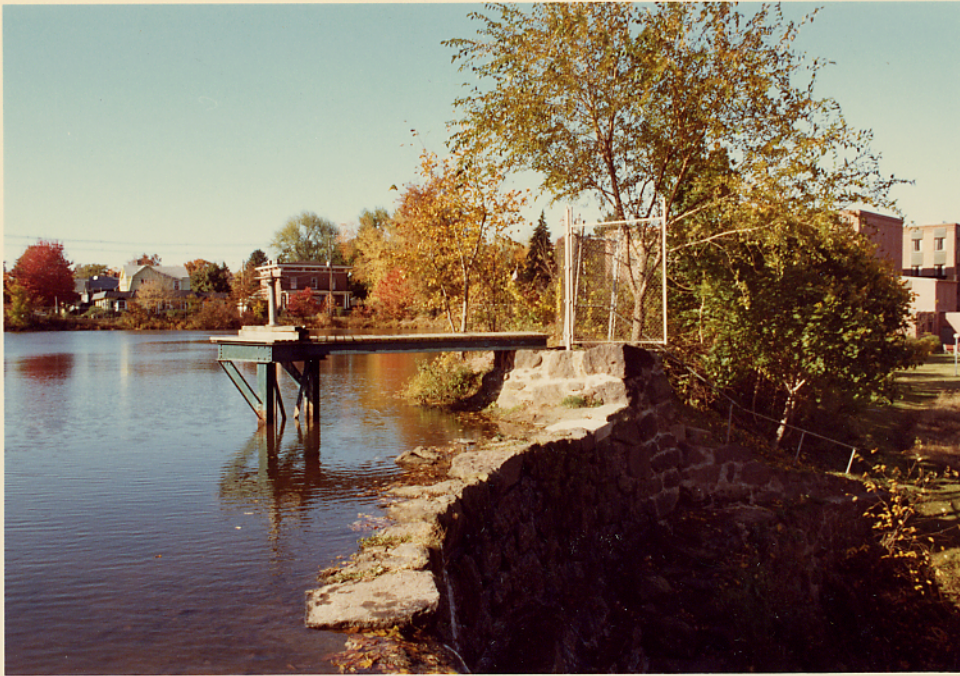
PHOTO 3

A service bridge extends about 20 feet from the south abutment to a low level discharge gate (Photo 3). The bridge, consisting of wooden boards on steel beams and columns, is in good condition. The gate is kept locked to inhibit vandalism. The gate is operable and controls a 27-inch metal low-level discharge pipe that passes through the base of the dam (Photo 6).

SPILLWAY - SOUTH ABUTMENT - CONTROL GATE

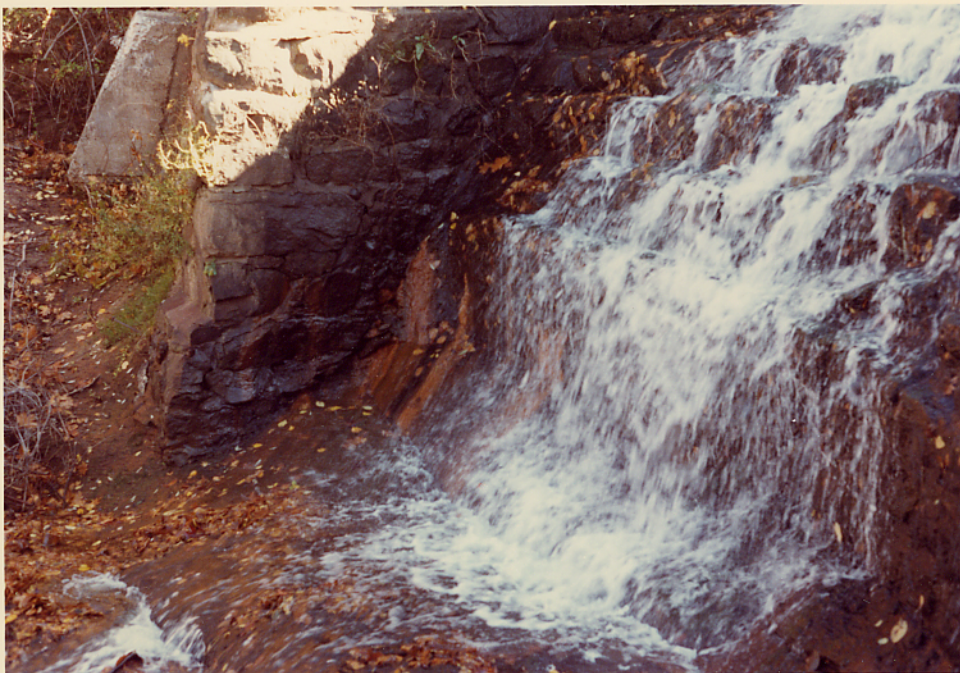
PHOTO 4

SPILLWAY - NORTH ABUTMENT

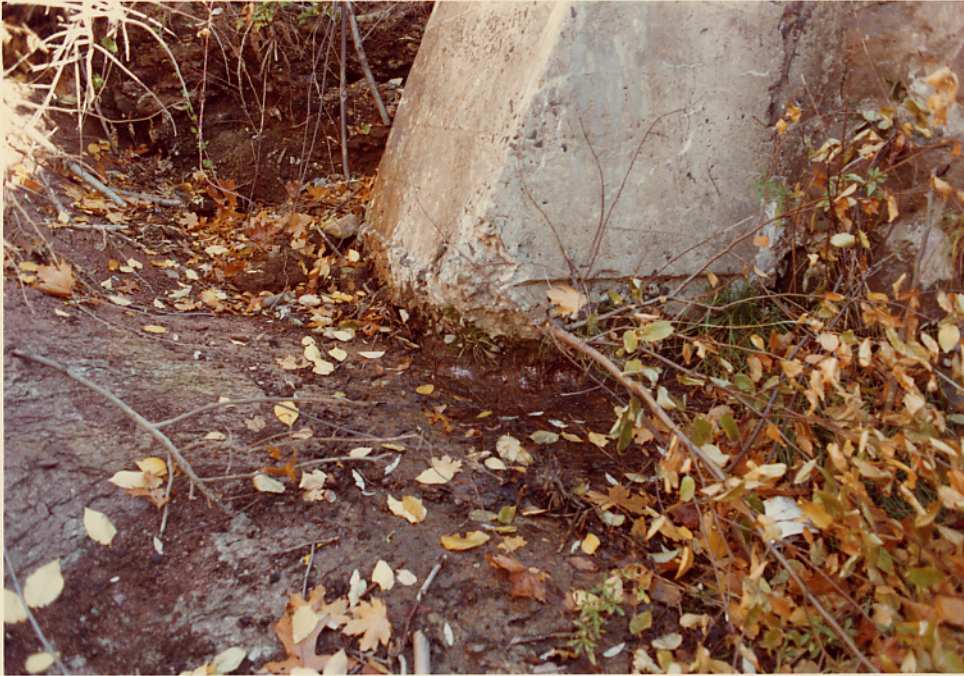
There are several areas of seepage through and adjacent to the masonry face of the dam (Photos 5 and 7 - See Photo Location Plan Plate 3 for location). On the north side of the spillway, below the auxiliary spillway is a concrete buttress that has seepage beneath it. It is undermined and spalled. The stone masonry face below the south side of the spillway and near the toe has seepage also. The amount of seepage at all locations could not be measured. The seepage was clear and showed no signs of particle movement.

PHOTO 5  
SEEPAGE - EROSION - DOWNSTREAM FACE

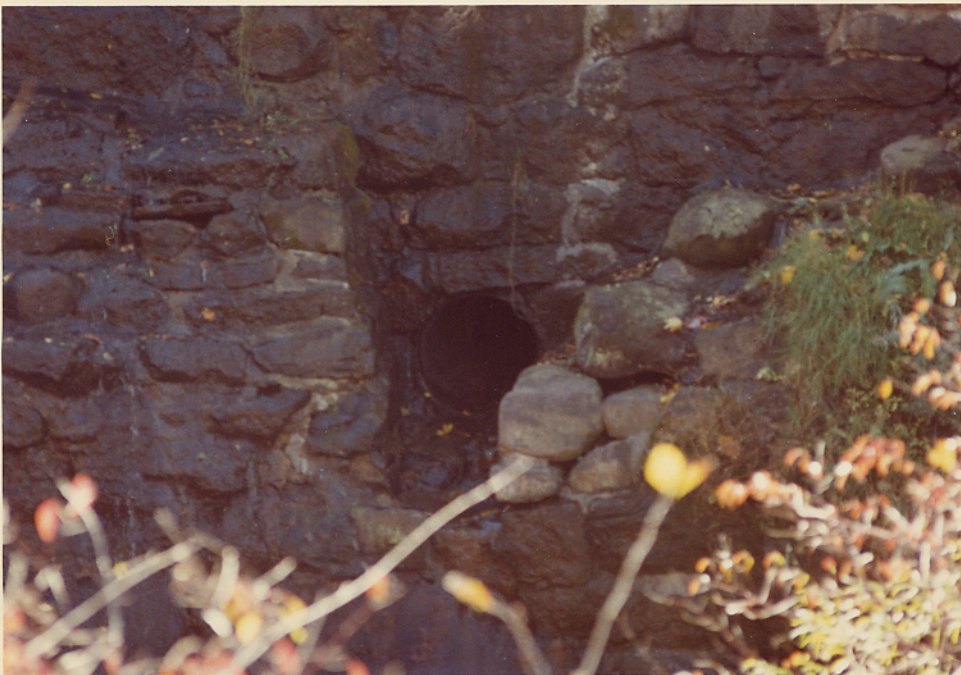
PHOTO 6  
LOW LEVEL DISCHARGE OUTLET

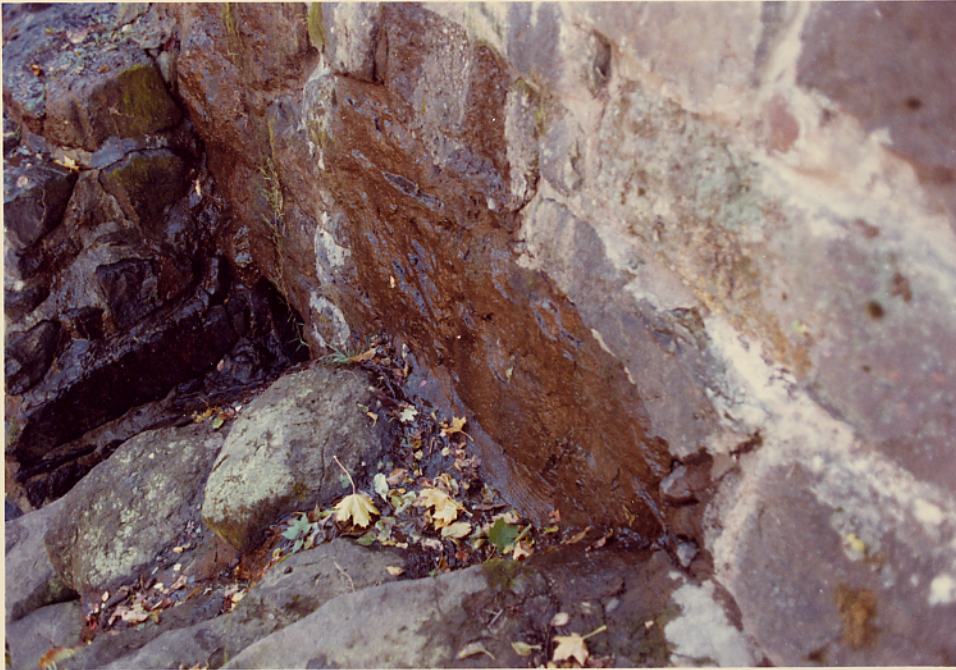
PHOTO 7

SEEPAGE - DOWNSTREAM FACE - LOW LEVEL DISCHARGE OUTLET

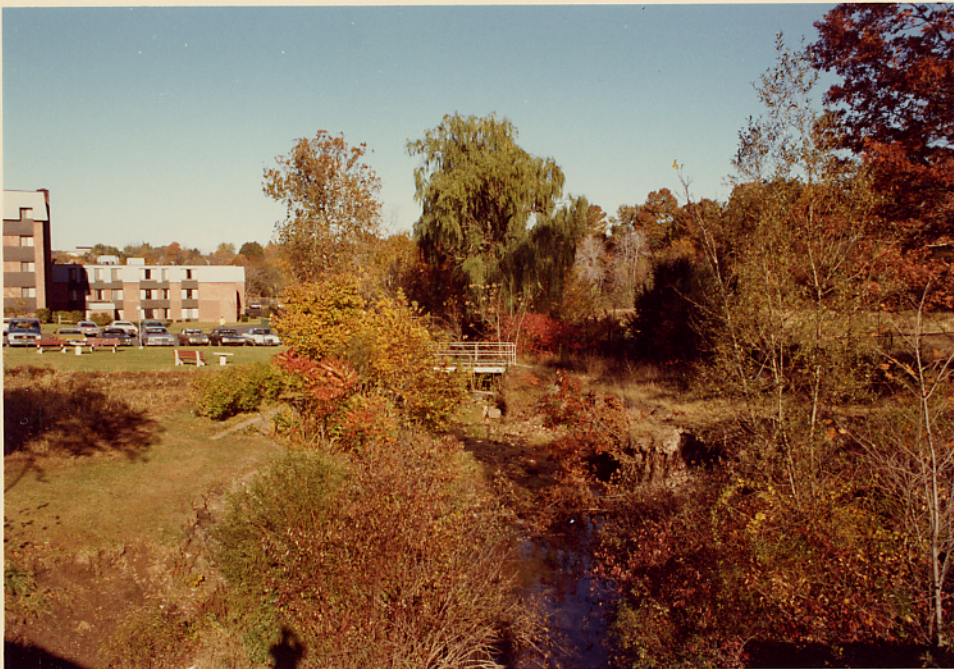
PHOTO 8

e. Downstream Channel - The downstream channel is natural with a stone masonry wall and a natural bank containing it (Photo 8). The northern bank near the dam are eroded somewhat and are covered with brush. Portions of the stone wall are out of alignment and in poor condition.

DOWNSTREAM CHANNEL

(3) Repair stone walls and eroded banks of downstream channel.
